**ARBORICULTURAL
IMPACT
ASSESSMENT**

Varley Solar Farm

September 2022

Barton Hyett Associates
Arboricultural Consultants

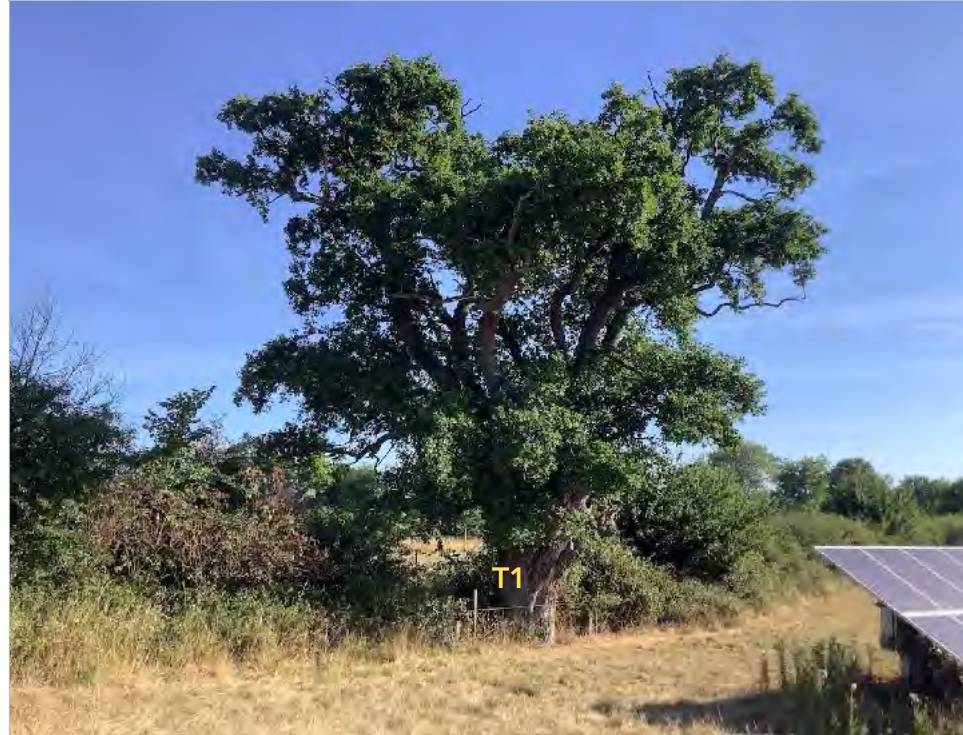
- 4.1. The oak T1 is a high-quality tree recorded as a veteran (A3). This tree has been classified as a veteran for the following reasons. The trunk diameter was recorded at 1600mm, when converted to a girth dimension this measures just over 5m. Oak as a species appears in Figure 1.3 in Lonsdale (2013)¹ and the girth of 5m places the tree as a veteran or notable tree. When T1 is assessed for veteran status it meets the criteria for characteristic features found on veteran trees (in para. 2.1.1 in Read, 2000²). With the exception of fungal fruiting bodies, T1 displays the following features; major trunk cavities, deadwood and crown retrenchment, dry crevices, bark loss, an old look (old pollard) and high aesthetic interest.

IMAGE 1: A view looking north-east at T1, a high-quality oak with many veteran characteristics.

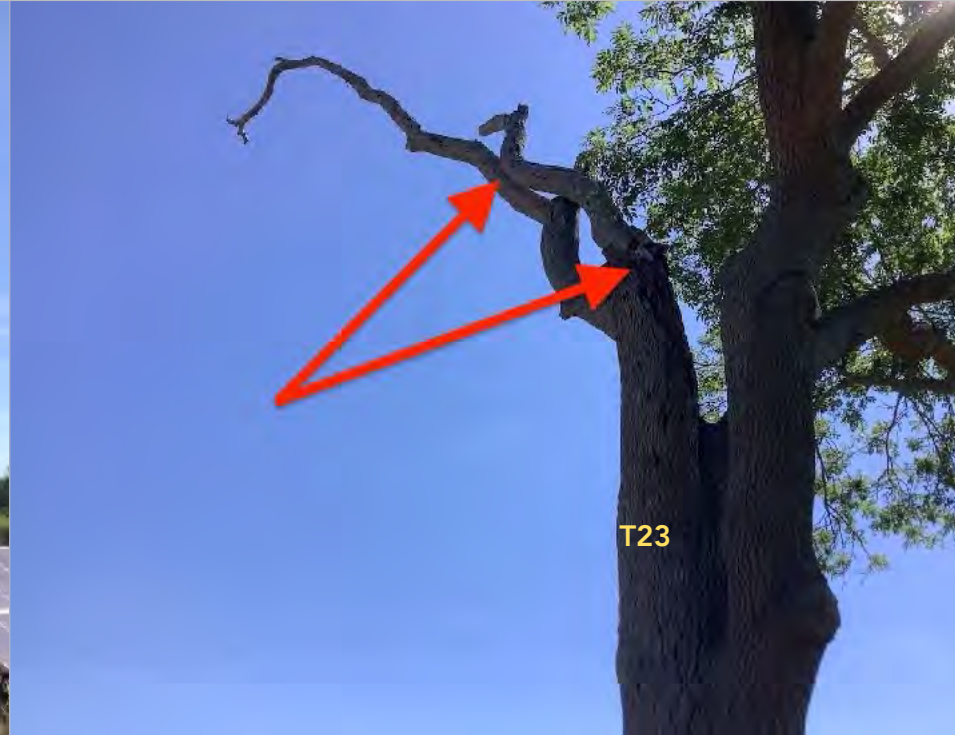
- 4.4. The ash T23 has a significant hung-up limb in the crown and this should be removed in the short term (see image 2 in **Section 3**). The tree also shows basal decay with associated bark damage and it is recommended that this tree be reduced to a habitat monolith and retained at a height of 7m.

IMAGE 2: A view looking north at T23, the fractured & hung-up limb is indicated.

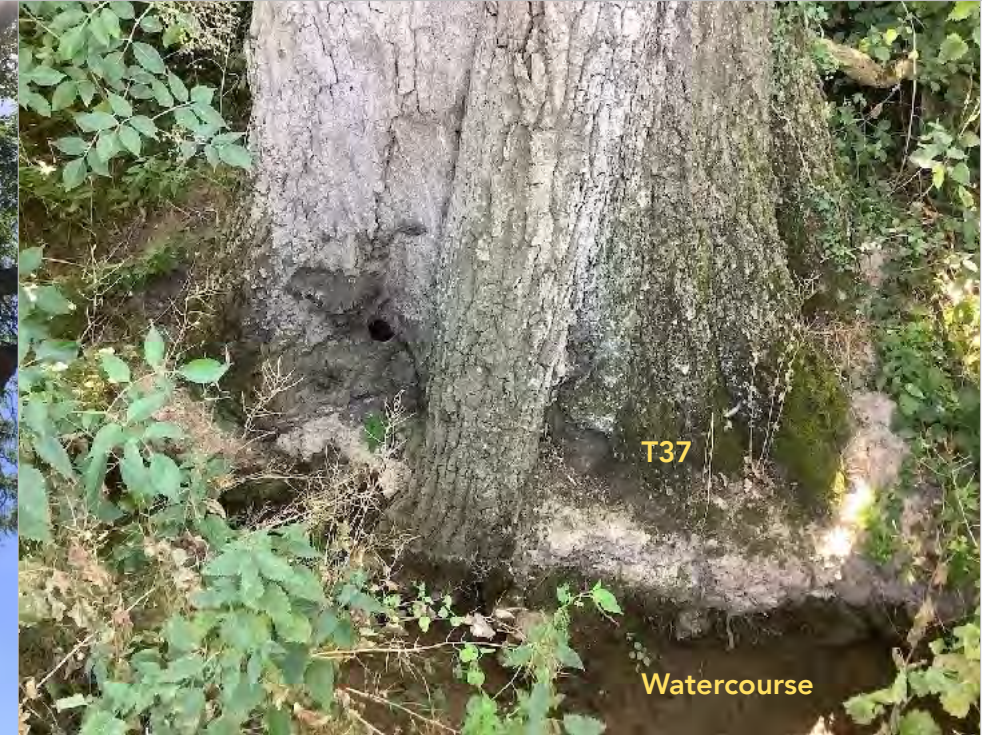
- 4.9. The oak T37 was recorded as high quality despite the decay noted at the root collar with *Ganoderma* fruiting bodies being present. The tree is immediately adjacent to a small drainage ditch and there are witness marks on the lower stem to denote a high water mark. During the morning of the first day of the site visit, the watercourse adjacent to T37 was observed to be dry - this was during a heatwave in mid-August. In the afternoon of the same day, the watercourse was observed to be running with water visibly in contact with the lower stem of T37. The water appeared to be discoloured, taking on a greyish colour.

IMAGE 3: A view looking south at the root-collar of T37 showing the close proximity of the watercourse and the witness marks of high water.

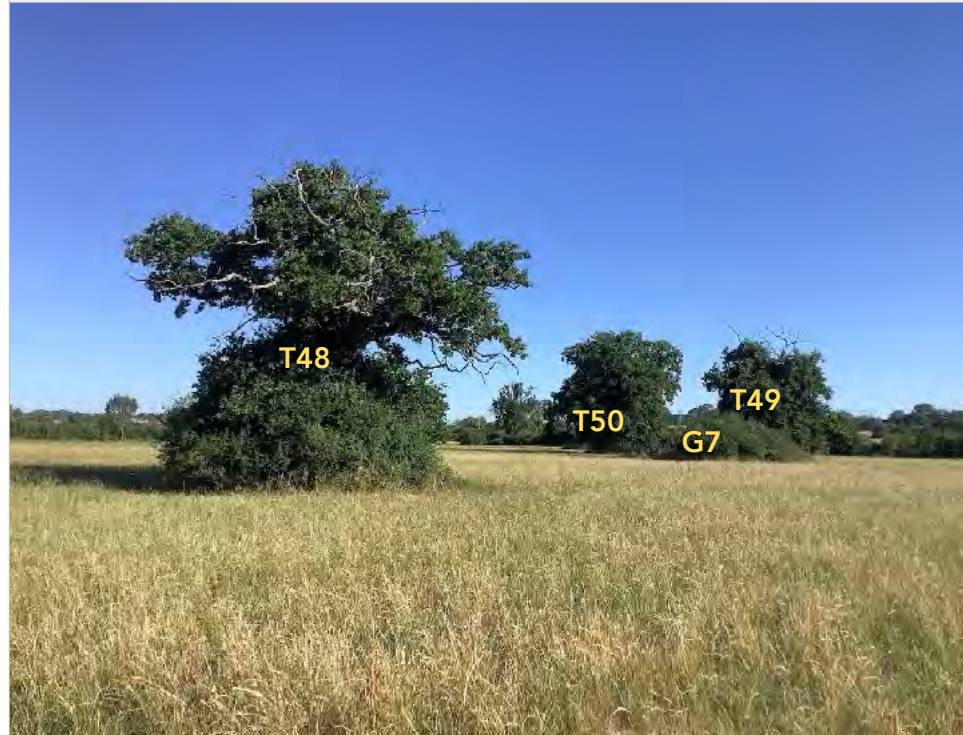
IMAGE 4: A view looking north at the in-field trees T48, T49 & T50 along with the group G7.

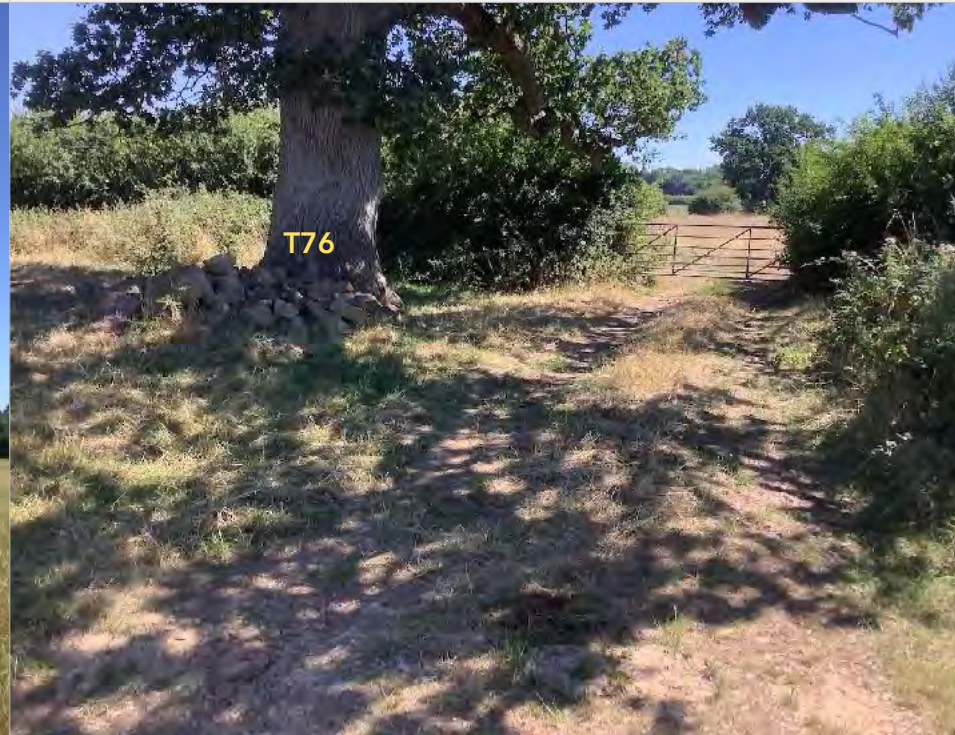
IMAGE 5: A view looking south-east at T76, showing the existing track and the pile of stones around the root-collar of the tree.

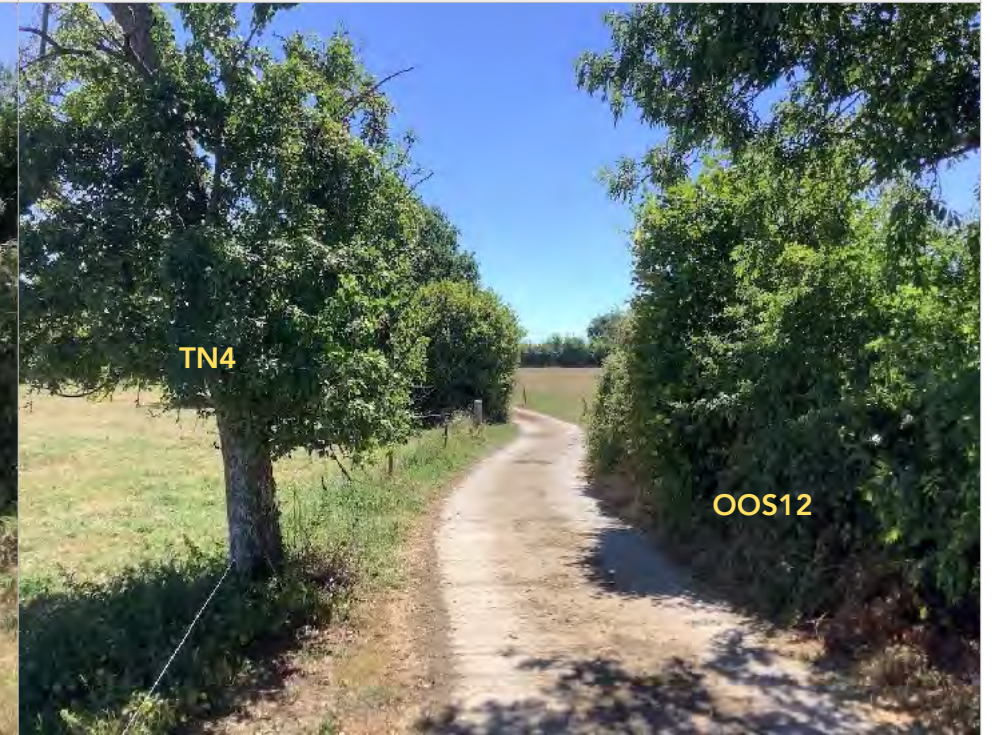
- 4.2. The 4m wide concrete access track is outside of the survey redline boundary, however, trees and arboricultural features adjacent to this track were recorded as OOS11, OOS12 and TN2 - TN5. The existing concrete will prevent further damage to the rooting zones of the adjacent trees and there is sufficient clearance at the track edge to allow agricultural machinery to pass unhindered.

IMAGE 6: A general view looking south along the 4m wide concrete track (which leads to Talbots End) and the proximity of TN4 and OOS12.
